**NASA TM X-1195**

**ANALYSIS OF AN EMERGENCY  
DECELERATION AND DESCENT OF THE  
XB-70-1 AIRPLANE DUE TO ENGINE DAMAGE  
RESULTING FROM STRUCTURAL FAILURE**

*by Chester H. Wolowicz*

*Flight Research Center  
Edwards, Calif.*

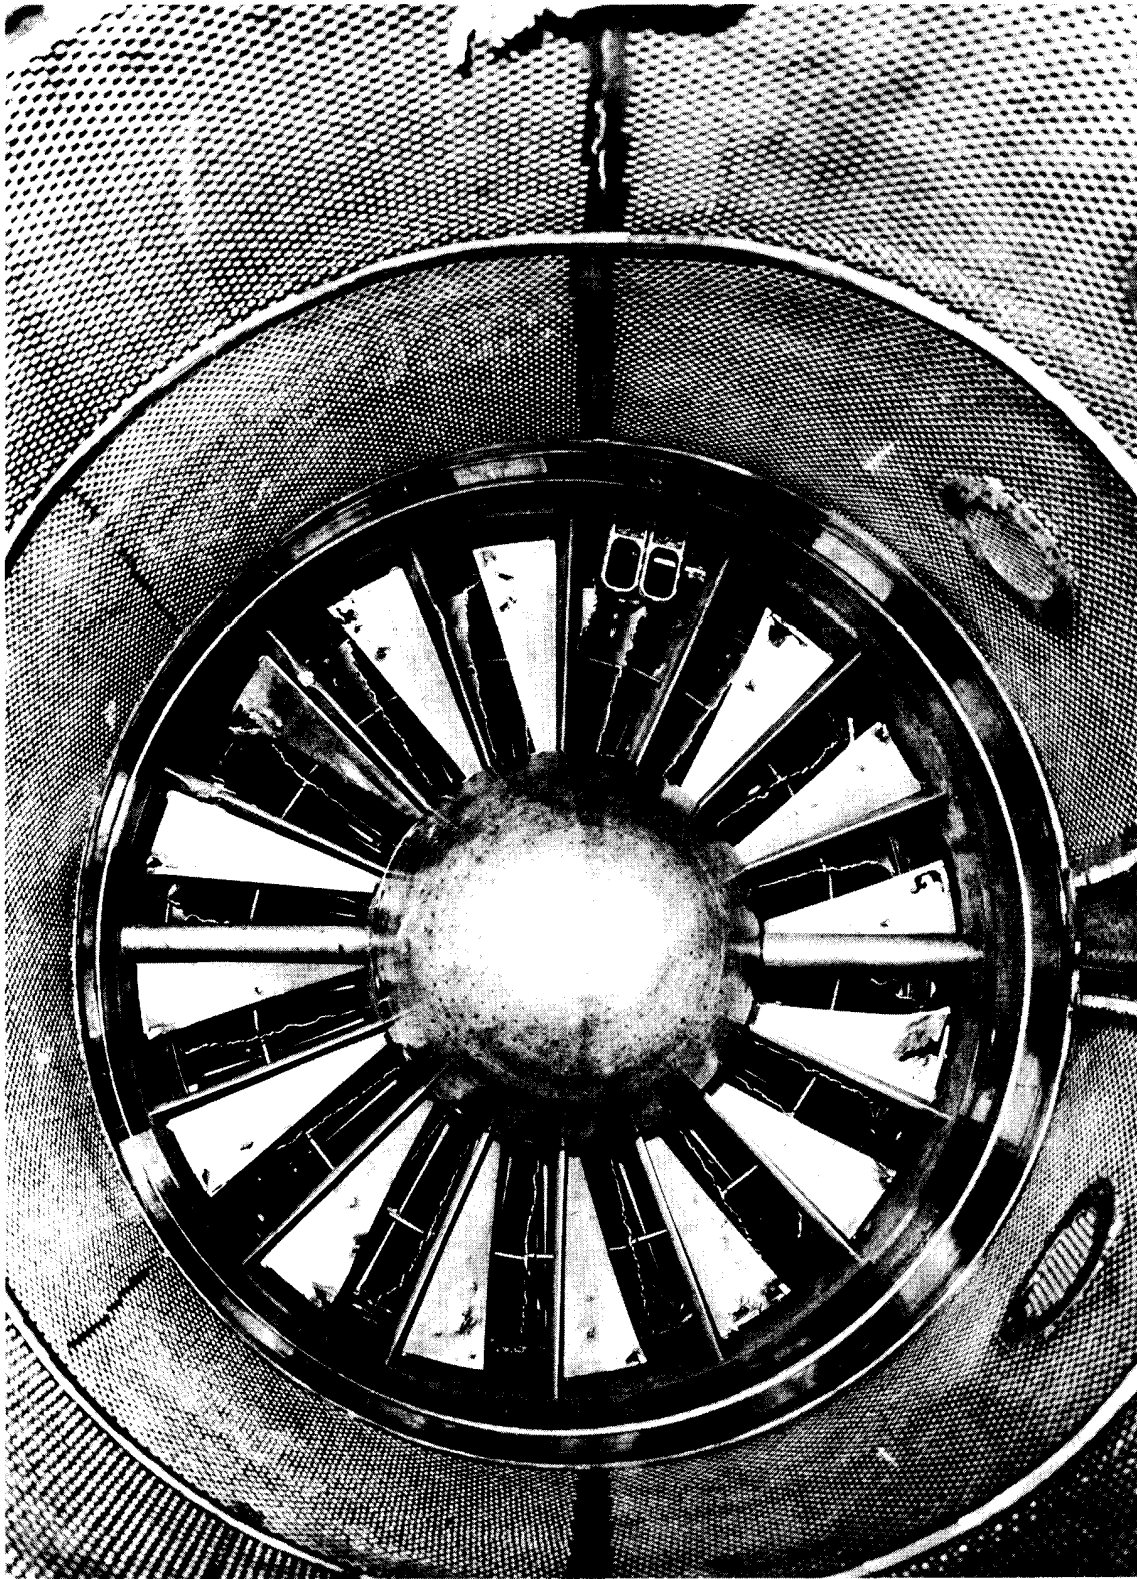
During the vibration at time 1:11:24,  $M = 1.87$ , engines No. 4 and No. 5 were shut down because of the continued stall condition of No. 4 and overtemperature of the exhaust gas on No. 5. At the same time, the throttles for engines 1, 2, and 3 in the left duct were retarded to idle. At time 1:11:27, the crew noticed that the right buzz light was on, and the copilot opened the right bypass doors to  $7^\circ$ . This appears to have caused the amplitude of the transverse vibrations to decrease to approximately  $\pm 0.2g$ . At time 1:11:45,  $M = 1.8$ , the bypass doors were closed down from  $7^\circ$  to  $4\frac{1}{2}^\circ$  without causing any significant increase in the amplitude of the vibration, probably due to the decreasing Mach number. At 1:11:52,  $M = 1.75$ , the bypass doors were opened to  $16\frac{1}{2}^\circ$ , causing the buzz and resonant oscillation to cease.

(b) No. 5 engine.
